North Coast Regional Water Quality Control Board

Inspection Report for September 18, 2019 Warrant Inspection Humboldt County Assessor's Parcel Number 220-301-006-000

File: Cannabis Program Inspections, Humboldt County, September 2019
HCSO/Green Wave Humboldt County Inspections, Vicky Dillon, CIWQS Place ID
863221

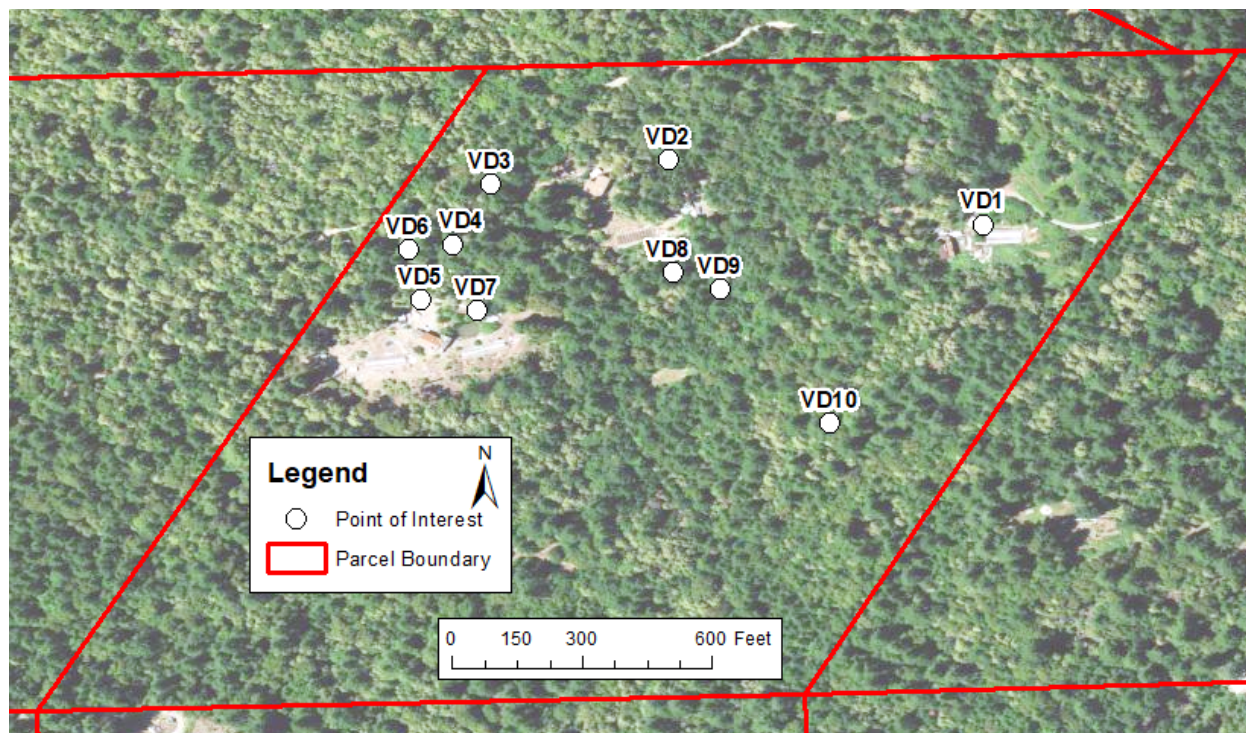
Figure 1: Map of Property with inspection points of interest

On September 18, 2019, I inspected the subject property. Figure 1 is a site map showing inspection points discussed in Table 1. I observed two areas containing outdoor cannabis cultivation. I observed an outhouse that discharges human waste to the ground. I observed three stream crossings that may be undersized for a 100-year flow event and associated debris. I observed two diversion points in a stream. I observed a watercourse diverted down a road, through a cross drain, and into a pond. I observed the pond had a small overflow culvert in the berm. I observed an overflowing water storage tank.
